# Sony TCM-919 Cassette-Corder Microphone Replacement

This guide aims to instruct Sony TCM-919 owners concerning the replacement of a faulty microphone in this cassette-corder.

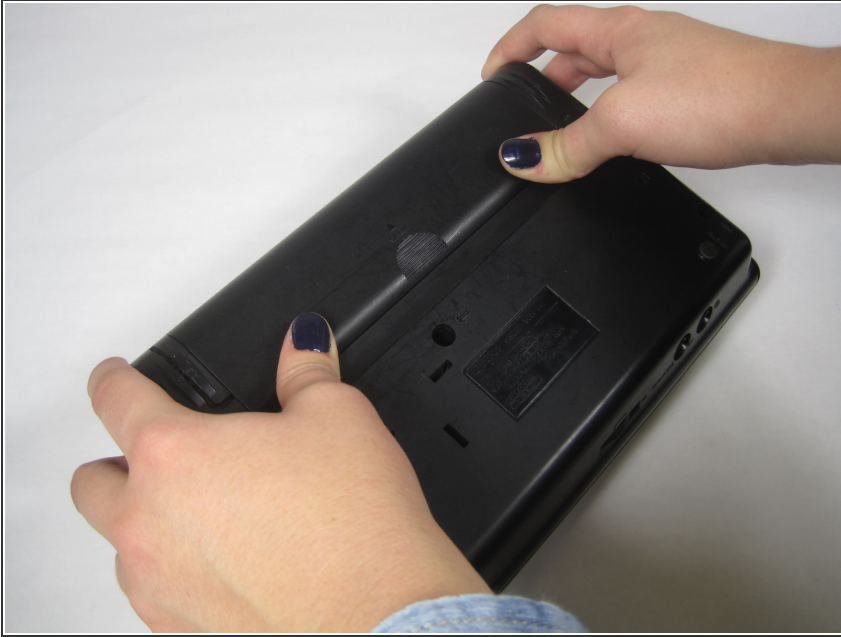
## Step 1 — Remove battery Cover

- Turn the device around so that the back cover is facing upward. Use your thumbs to press down firmly and then push the battery door cover open.
- Remove any batteries.

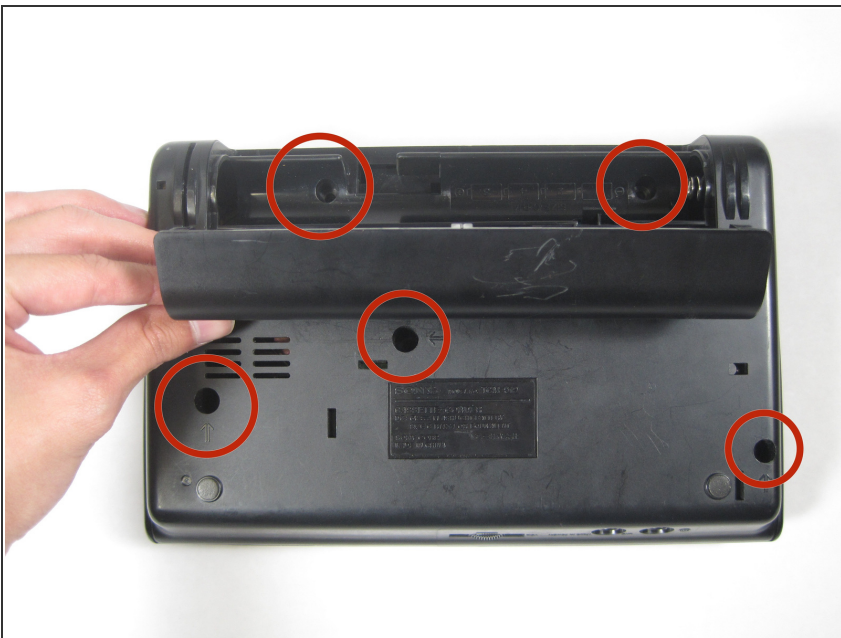
## Step 2 — Remove Back Casing

- Remove the 5, 5.95mm screws as indicated in the picture using the Phillips head screwdriver.

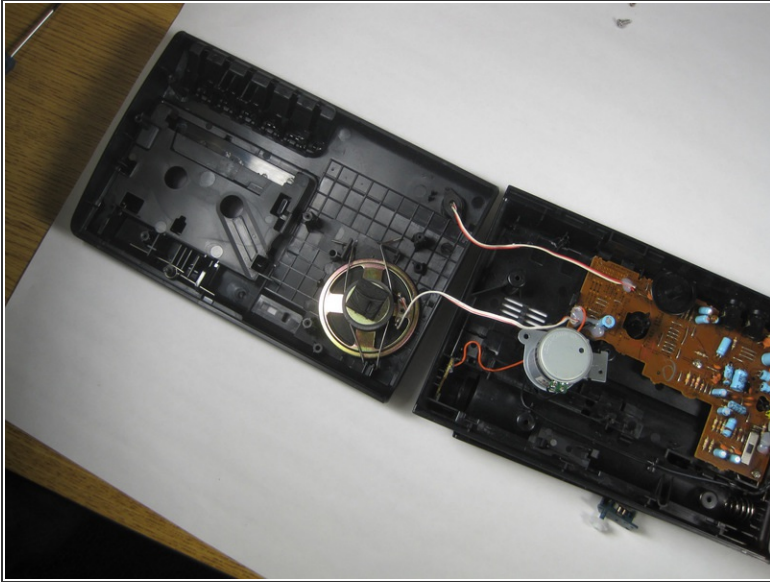
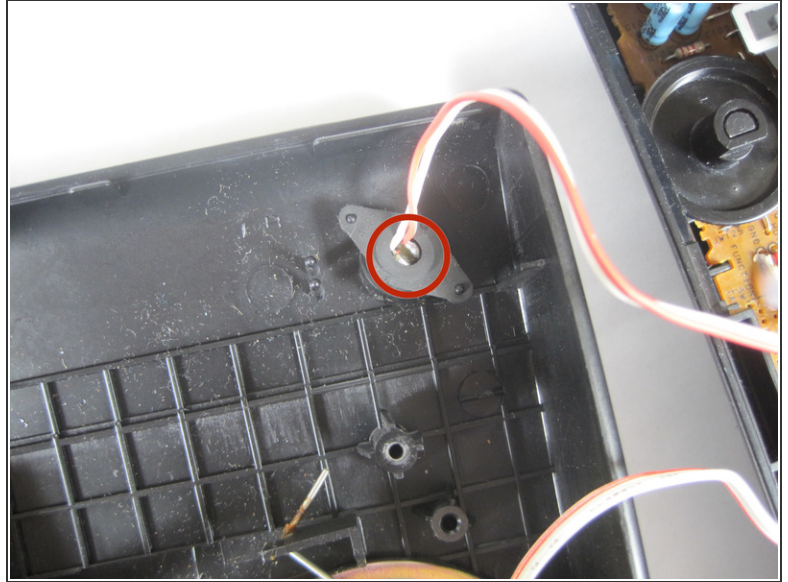
### Step 3 — Desolder Microphone Wires

- Look to the back of the top cover.
- Desolder the two wires connected to the microphone using the soldering station.

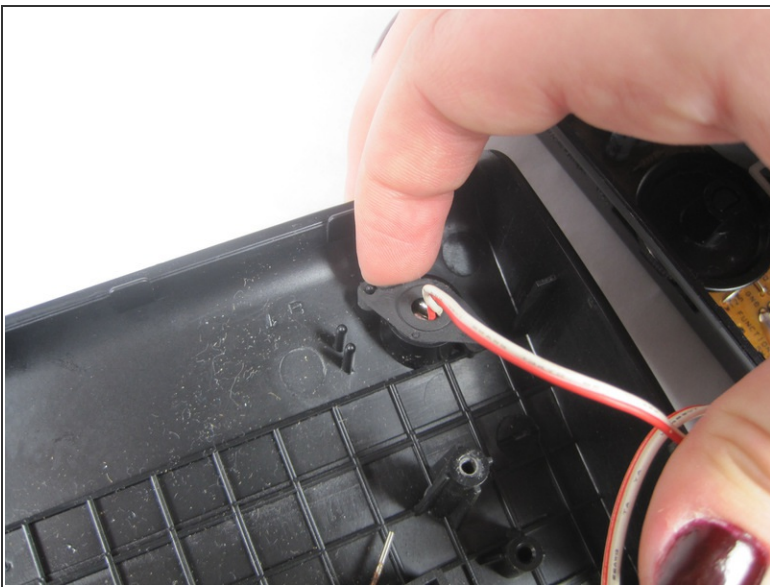
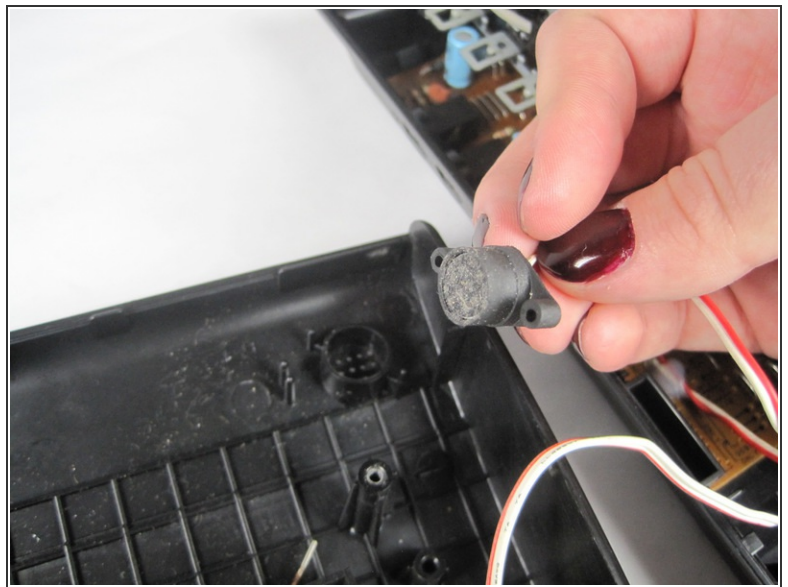
### Step 4 — Remove Microphone

- Gently remove the rubber top from the two plastic knobs that hold the microphone in place.
- Remove the microphone by pulling up.
